RAIL TRANSPORTATION SAFETY INVESTIGATION REPORT R18H0105

MAIN-TRACK COLLISION BETWEEN TRAIN AND TRACK UNIT

Canadian National Railway Company
Freight train X 14921-01 and
Unimat tamper
Mile 84.27, Kingston Subdivision
Crysler, Ontario
02 October 2018

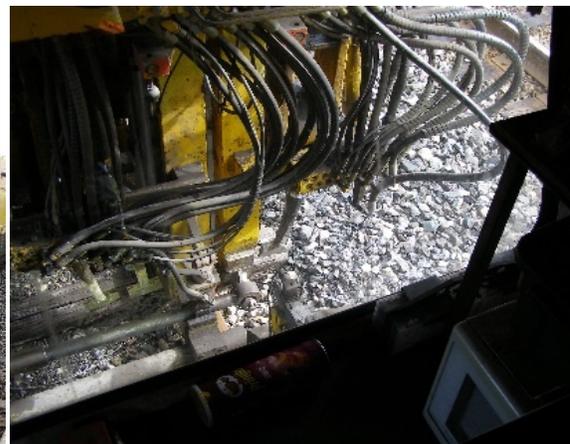
Figure 6. Operator's view of the tamping tools from inside the tamper, looking through the viewing area at the bottom of the workstation (Source: TSB)

At the time of the occurrence, the Unimat tamper was being operated with its long nose leading (Figure 5). When seated at the operator workstation, the operator trainee could visually estimate how far the tamping tools were extended by leaning forward and looking through the viewing area (clear glass) located at the bottom of the workstation (Figure 6).
