MARINE TRANSPORTATION SAFETY INVESTIGATION REPORT M17C0179

BOTTOM CONTACT AND SUBSEQUENT FLOODING

Passenger vessel *Island Queen III*
Kingston, Ontario
08 August 2017

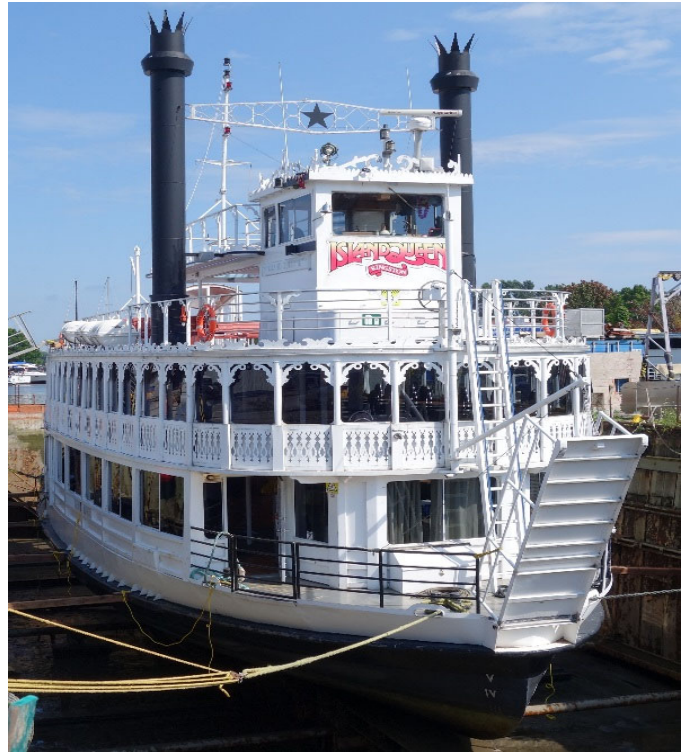
Figure 1. The *Island Queen III* (Source: TSB)

The *Island Queen III* (Figure 1) is a triple-decked passenger vessel with a decorative paddle wheel located at the stern and a functional gangway at the bow. The general arrangement of the vessel is shown in Appendix A.
