# AIR TRANSPORTATION SAFETY INVESTIGATION REPORT A23Q0143

## NEAR COLLISION WITH TERRAIN ON FINAL INSTRUMENT APPROACH

Boeing of Canada Ltd. De Havilland Division DHC-8-106, C-FLSX

Val-d'Or Airport (CYVO), Quebec

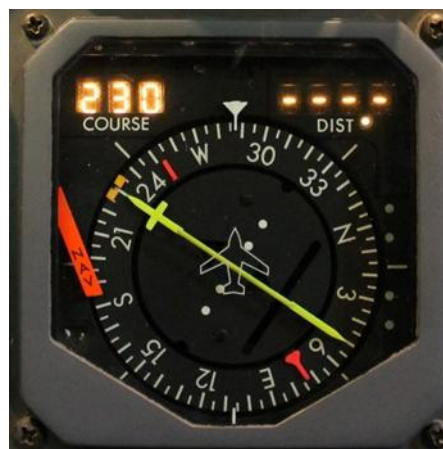
Figure 2. Horizontal situation indicator on the occurrence aircraft (Source: TSB)

In this occurrence, when the approach was activated (ACT APPR), after leaving the holding pattern at IKDOB, both the PF's and the PNF's HSIs were lined up with the final approach course (182°). The occurrence aircraft did not have a navigation screen showing the aircraft's position on a map.

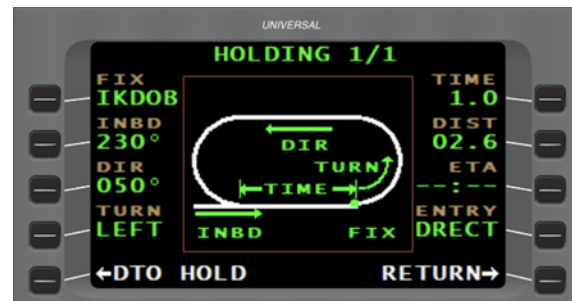
Figure 8. Holding pattern definition page (Source: Universal Avionics, FMS Trainer v4.1.0.600)

If a flight crew activates the DTO HOLD [direct to hold] function on this page (bottom left on Figure 8) to fly directly to the holding pattern defined at IKDOB without changing the

default waypoint, the FMS will navigate directly to the final IKDOB waypoint (12th item on the flight plan), at the end of the missed approach.

Then, when the PNF attempted to add a holding pattern at the IKDOB waypoint before the approach (the 5th item on the flight plan), by default, the FMS suggested the preprogrammed hold at the IKDOB waypoint at the end of the missed approach (the 12th item on the flight plan) (see section 1.6.4.2 *Holding pattern page*). On the FMS holding pattern definition page, there was nothing in the field displaying IKDOB that indicated which of the 3 IKDOB waypoints on the flight plan was being used (Figure 8, section 1.6.4.2 *Holding pattern page*). Given that the PNF did not change the IKDOB waypoint provided by default, when the DTO HOLD [direct to hold] function in the bottom left of this page was activated, the FMS navigated to the IKDOB missed approach holding pattern corresponding to the final waypoint on the flight plan (12th item on the flight plan). On the FMS main navigation page (NAV 1/3), it was not possible to see that there were no further waypoints after the holding pattern (Figure 10, section 1.6.4.3 *Navigation pages*).

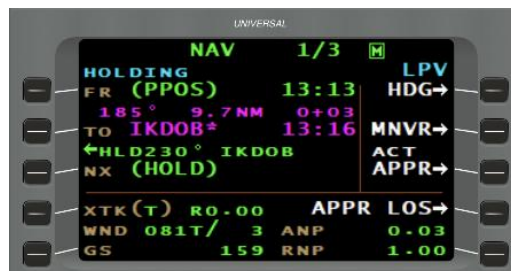
Figure 10. Main navigation page en route to IKDOB after the holding pattern was programmed (Source: Universal Avionics, FMS Trainer v4.1.0.600)

After the IKDOB holding pattern was programmed, the main navigation page still displayed PPOS to IKDOB, and the next waypoint was replaced by the holding pattern (HOLD) (Figure 10), meaning that the holding pattern would be flown at IKDOB.

The blue indication of HOLDING [holding pattern] mode at the top left of the screen meant that the FMS was in the holding pattern mode.

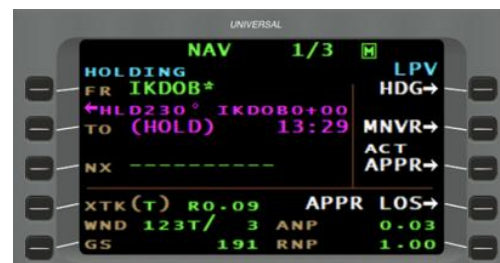
Figure 11. Main navigation page when the aircraft was established in the holding pattern at IKDOB (Source: Universal Avionics, FMS Trainer v4.1.0.600)

After the aircraft flew over waypoint IKDOB to enter the holding pattern, the main navigation page displayed from IKDOB to HOLD, and the next waypoint was replaced with dashes (Figure 11), indicating that there was no waypoint immediately after IKDOB.

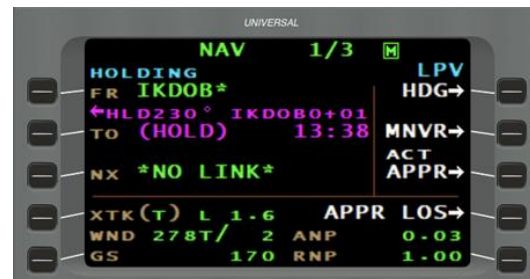
Figure 13. Main navigation page after activating the PROCEED [proceed to] function to exit the holding pattern (Source: Universal Avionics, FMS Trainer v4.1.0.600)

After the PROCEED function was selected, the main navigation page still displayed from IKDOB to HOLD, and the dashes at the next waypoint were replaced by \*NO LINK\*, indicating that there was no waypoint immediately after the holding pattern at IKDOB (Figure 13).
