PIPELINE TRANSPORTATION SAFETY INVESTIGATION REPORT P24H0018

PIPELINE RUPTURE AND FIRE

NOVA Gas Transmission Ltd.
36-inch Grande Prairie Mainline
Near Edson, Alberta
16 April 2024

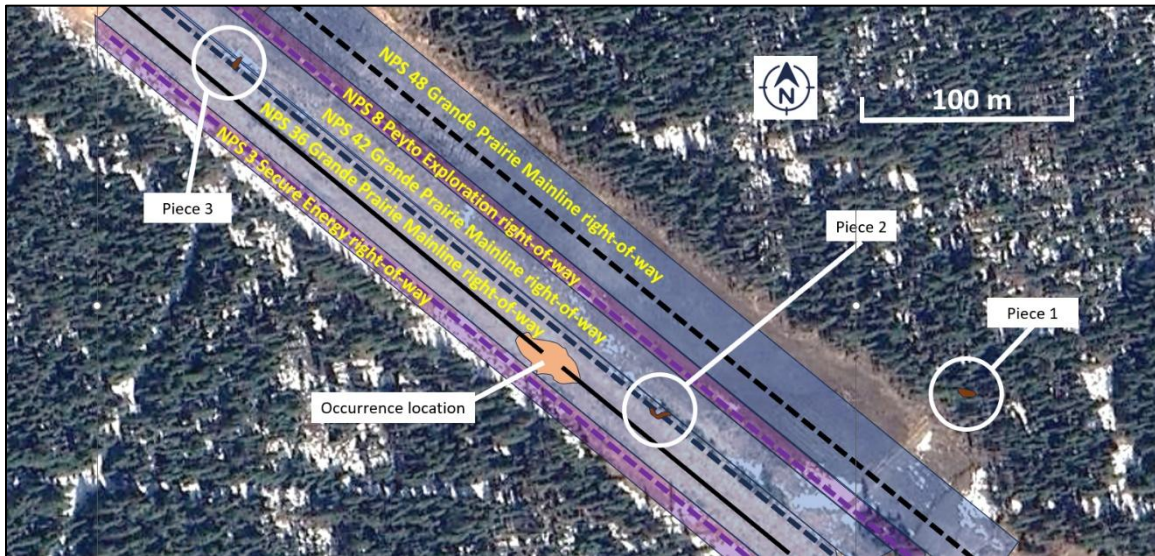
Figure 4. Occurrence location details (Source: Google Earth Pro, with TSB annotations)

The NPS 36 Grande Prairie Mainline was exposed at both the upstream and downstream ends of the ruptured section. Three large pipe pieces⁷ that were ejected during the rupture were located in the vicinity of the crater (Figure 4). All of the ejected pipeline material, approximately 20 m, was recovered. The largest piece, which included the rupture origin, was located 200 m east of the occurrence location (Figure 5). No damage to other nearby NGTL or third-party infrastructure was reported.

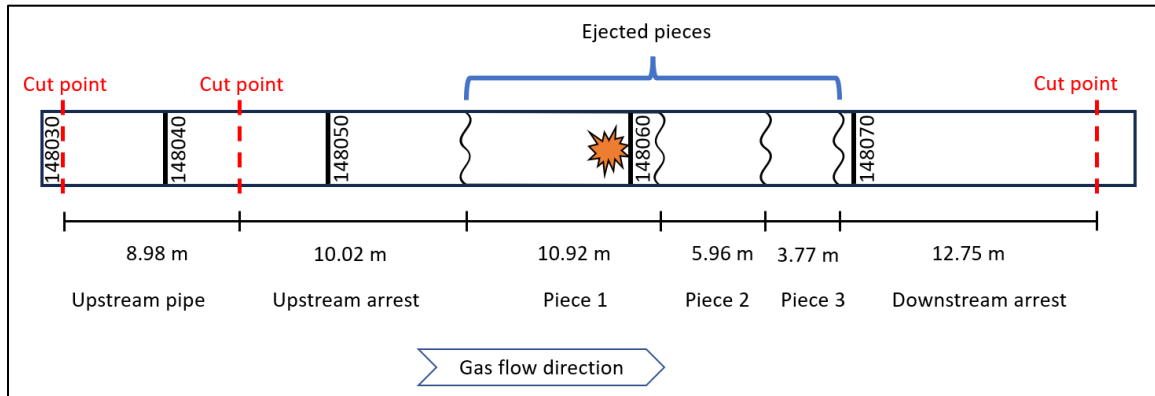
Figure 7. Material recovered for laboratory examination (Source: TSB)

Three ejected pipe pieces were secured on site at the occurrence location. Sections of pipe, including where the fracture stopped propagating, were excavated and cut out. The recovered pipe material was from pipe joints¹³ 148030 to 148070 (Figure 7). The ejected pieces, cut-out pipe sections, and soil samples were sent to Acuren Laboratories in Edmonton, Alberta, to determine the mechanical properties of the pipeline and its mode of failure.

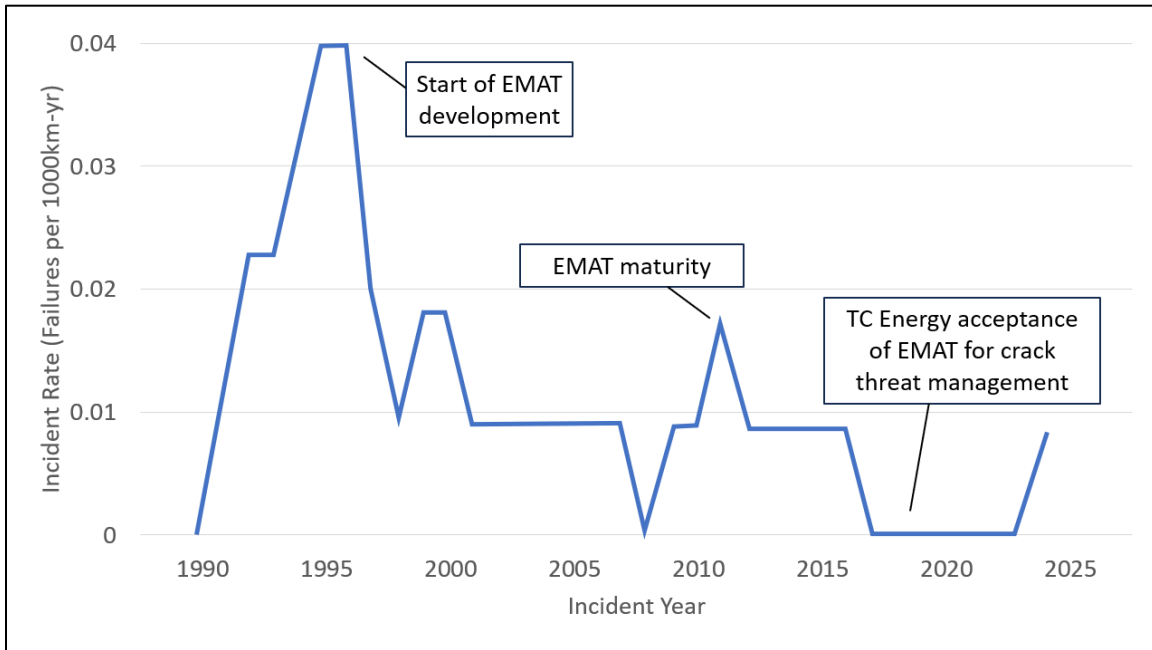
Figure 12. TC Energy stress corrosion cracking failure occurrence rate (Source: data from TC Energy)

SCC failures on TC Energy's pipelines prompted inquiries by the National Energy Board in 1993 and 1995. These inquiries contributed to the understanding of SCC and how to manage its effects. Since that time, EMAT technology has matured to become the primary tool for TC Energy and the rest of the pipeline industry to manage SCC. The frequency of SCC failures has declined since the adoption of this technology. After a validation period, TC Energy accepted the use of EMAT ILI in 2018 as the primary tool for the management of SCC. This occurrence is the first instance of a rupture on a TC Energy pipeline that has been inspected by an EMAT tool (Figure 12).
