Transportation  
Safety Board  
of Canada

# MARINE TRANSPORTATION SAFETY INVESTIGATION REPORT M23P0235

## ACCIDENTAL RELEASE OF FREE-FALL LIFEBOAT AND CREW INJURY

Bulk carrier *Golden Zhejiang*  
Trincomali Channel, British Columbia  
02 September 2023

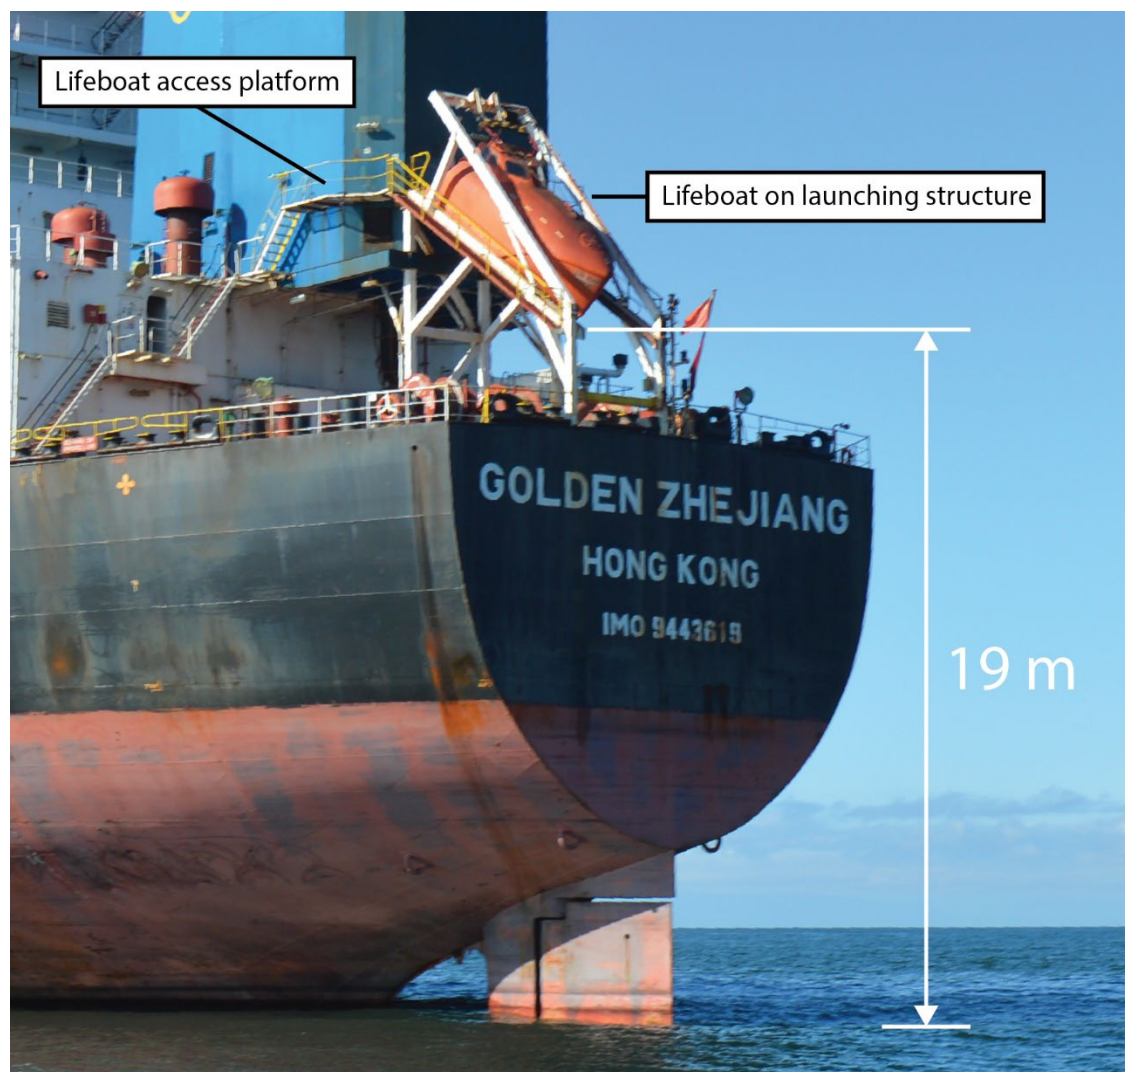
Figure 2. The free-fall lifeboat stowed on the launching structure and the lifeboat access platform (Source: TSB)

The *Golden Zhejiang* is equipped with a free-fall lifeboat. The lifeboat is stowed on a launching structure located at the stern (Figure 2). On the day of the occurrence, the lifeboat was about 19 metres above the water surface. The lifeboat is positioned with its bow down at an angle of approximately 30° toward the vessel's stern. It weighs 4400 kg when empty and its length overall is 7.5 m.

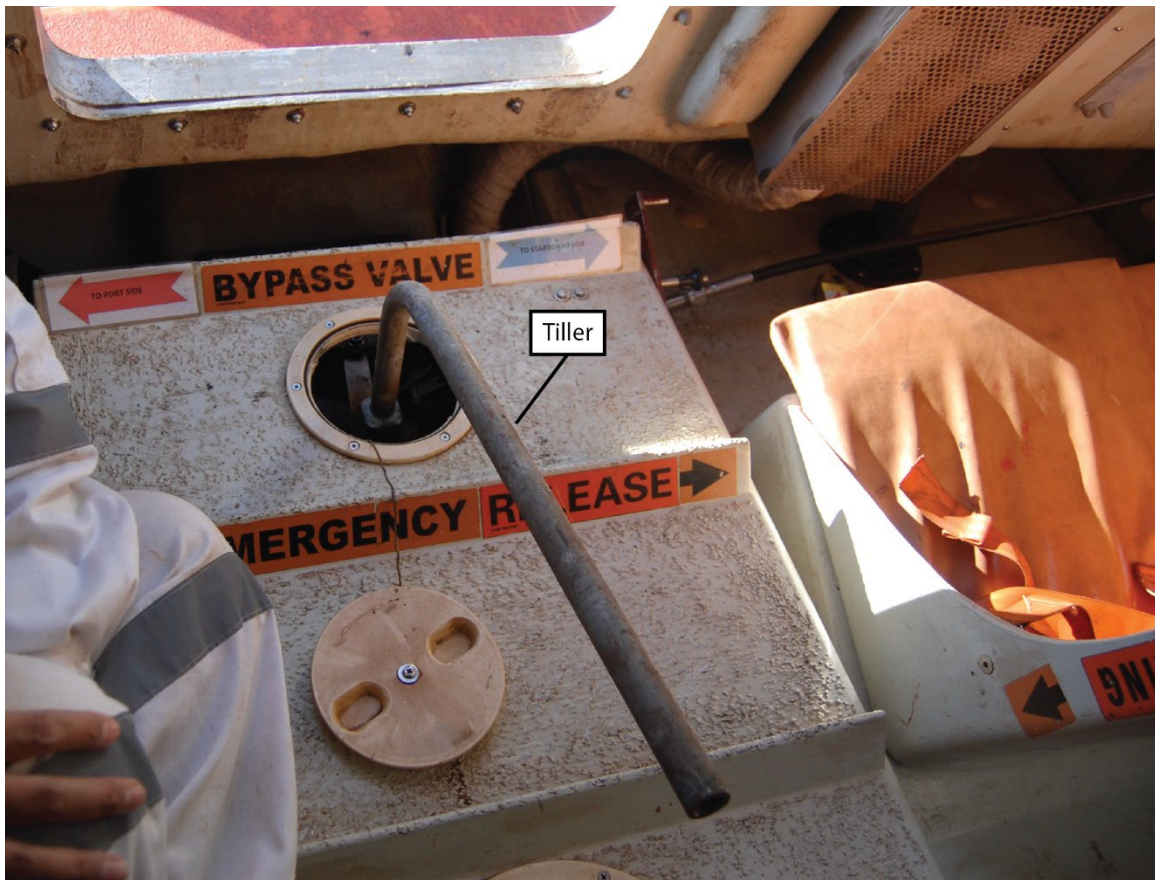
Figure 5. The tiller for operating the emergency steering (Source: TSB)

The lifeboat's emergency steering is immediately in front of the door under a deck plate. The emergency steering is operated with a tiller, as is typical (Figure 5). The second engineer was familiar with this arrangement from his general experience with lifeboats on other vessels.

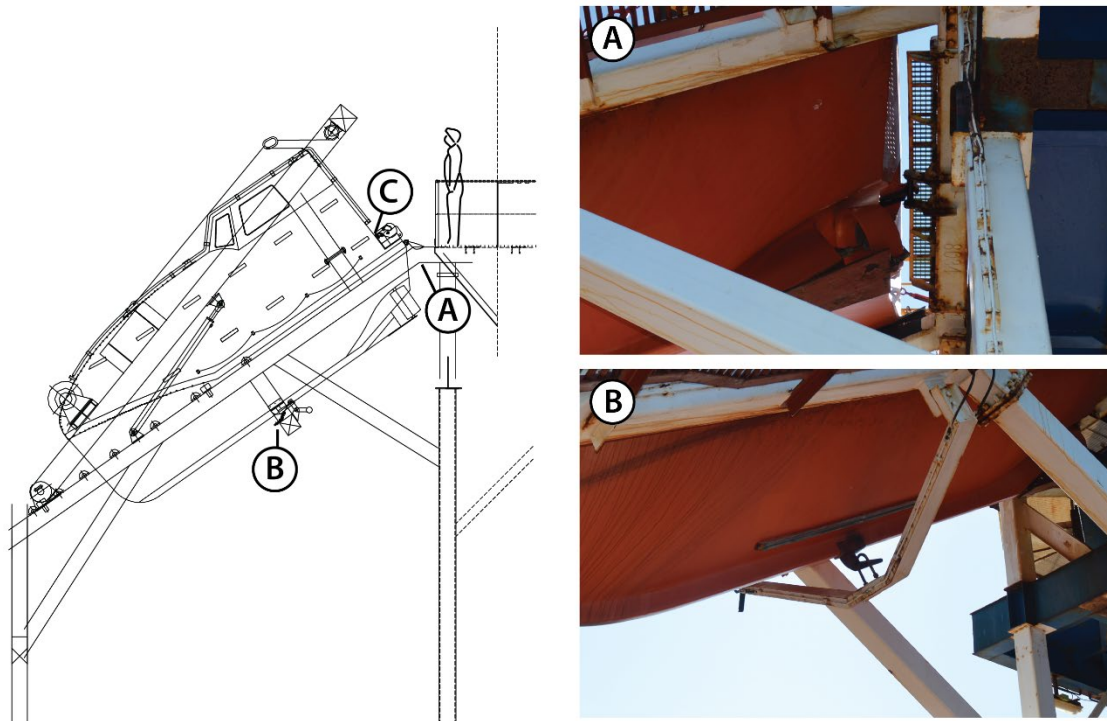
Figure 8. When the Golden Zhejiang was at sea, the lifeboat was secured with the release hook (A), a keel hook (B), and a strap (C). (Source of main image: TSB, based on general arrangement drawings. Source of insets: TSB)

When the *Golden Zhejiang* was at sea, the lifeboat was secured in the following ways (Figure 8):

- It was held to the launching structure with the release hook.
- It was protected against movement caused by the vessel's motion by a strap over the stern.
- It was held in position on the launching ramp by a keel hook.
