AIR TRANSPORTATION SAFETY INVESTIGATION REPORT A23P0153

COLLISION WITH TERRAIN

Wilderness Seaplanes Ltd.

Grumman G-21A, C-GDDJ

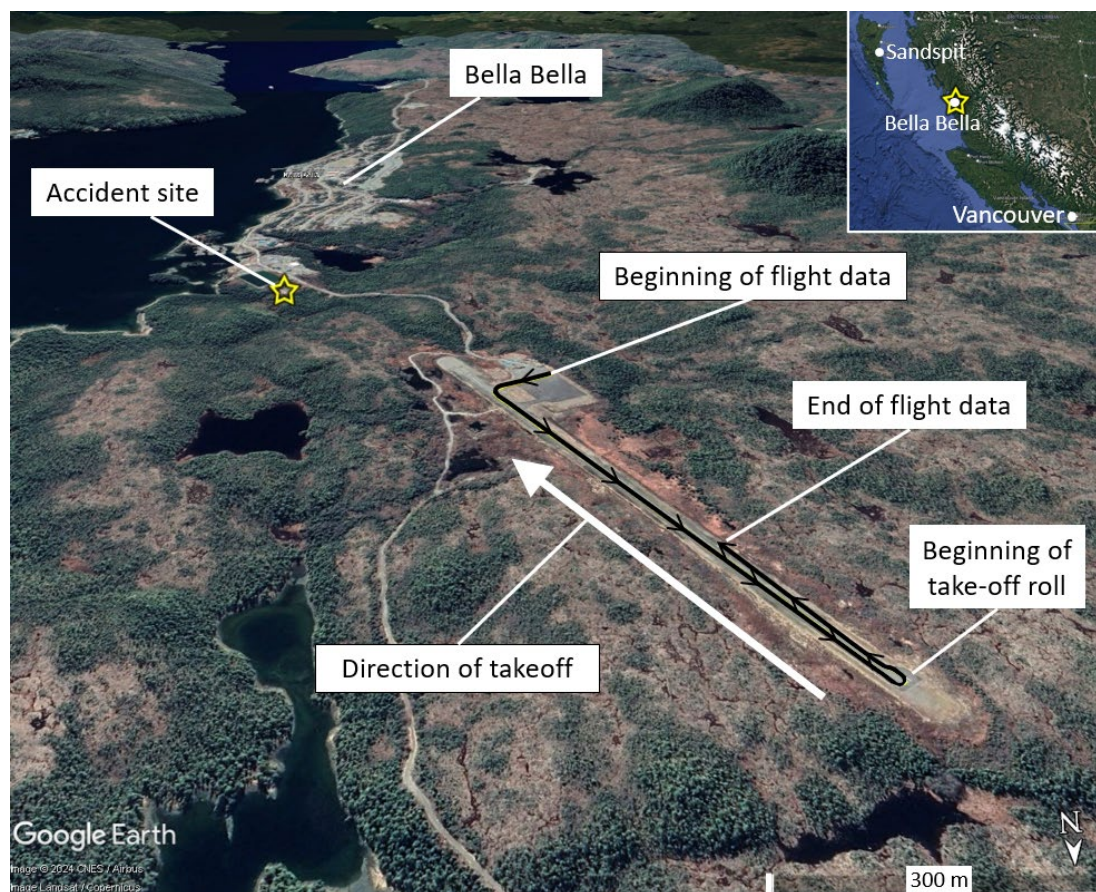
Figure 1. Map showing recorded flight data and accident site with an inset showing the location of Bella Bella (Source of main and inset images: Google Earth, with TSB annotations)

At 1428,² the aircraft departed Runway 13 at CBBC. Shortly after takeoff, while climbing through approximately 150 feet above ground level (AGL), the left engine surged and lost power. Seconds later, the right engine also lost power. The pilot transmitted a Mayday call on the aerodrome traffic frequency (ATF) and attempted to retract the landing gear, but there was insufficient time to do so using the manual system. The pilot performed a forced landing, and the aircraft came to rest in a forested area approximately 600 m from the departure threshold of the runway, and 130 m left of the extended centreline (Figure 1).
