# AIR TRANSPORTATION SAFETY INVESTIGATION REPORT A25P0041

## COLLISION WITH TERRAIN

Chinook Helicopters (1982) Ltd.

Cessna 172S, C-GHCC

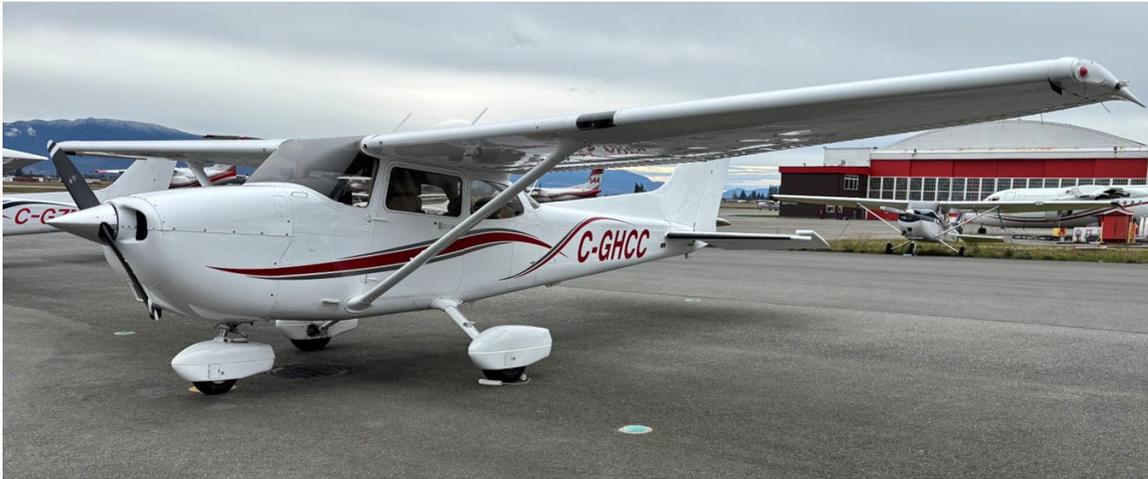
The occurrence aircraft was a Cessna 172S manufactured in 2007 (Figure 3). It was equipped with a Lycoming IO-360-L2A fuel-injected engine and a metal, fixed-pitch propeller. At the time of the occurrence, the aircraft had flown approximately 7802 hours. The aircraft's last annual inspection occurred on 31 March 2025.

Figure 3. Occurrence aircraft, photo taken before the occurrence (Source: Third party, with permission)
