AVIATION INVESTIGATION REPORT

A14Q0155

Runway excursion

Airbus A330-343, C-GFAF

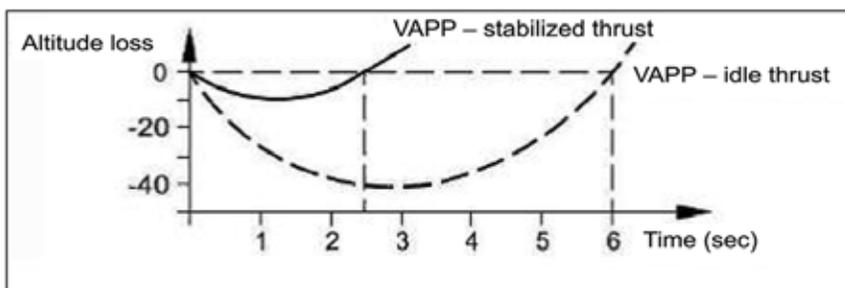
Figure 4. Loss of altitude following a go-around (Source: Airbus Flight Crew Training Manual No. 180)

The loss of altitude is approximately 10 feet when the thrust is stabilized, but can reach 40 feet when the thrust is at idle power (Figure 4). According to Airbus, it may take up to 6 seconds before a positive rate of climb is achieved. The Airbus data is consistent with information gathered during simulator tests performed by the TSB (see section 1.17.2 Simulator session).

The delays before a positive rate of climb was achieved that were observed during the simulator session is consistent with the Airbus data in Figure 4 of section 1.6.10 Go-around.

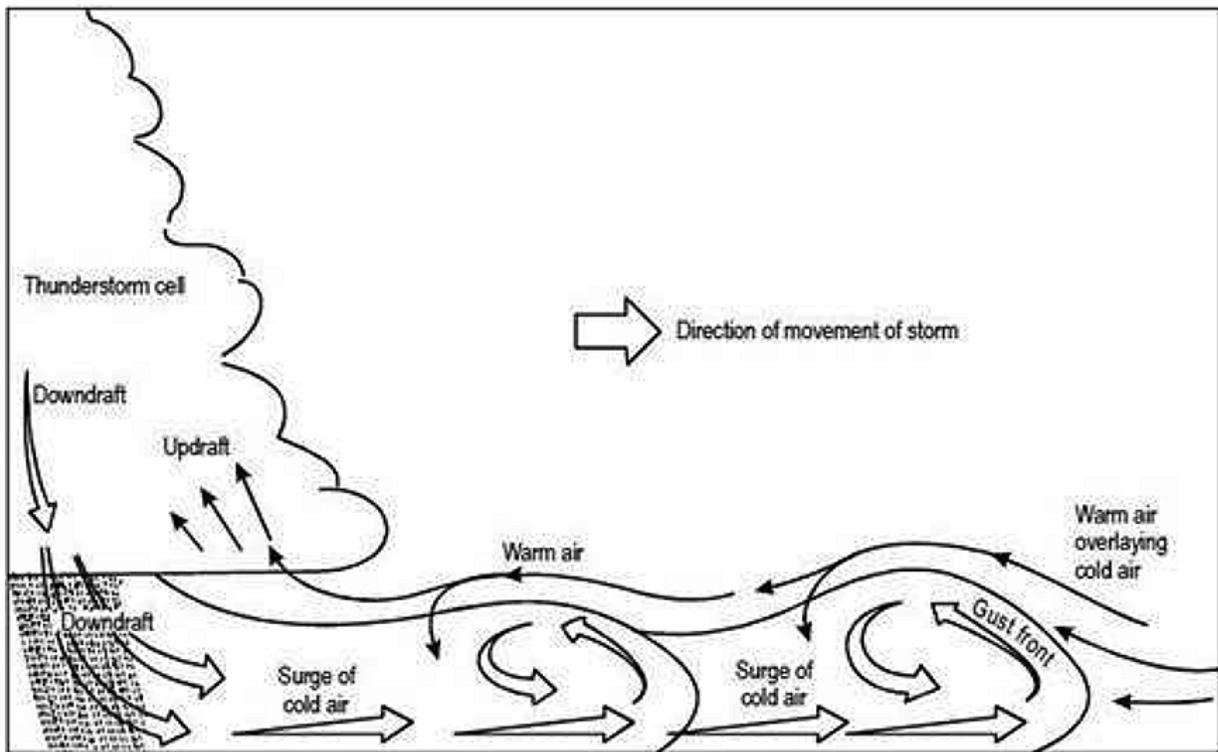
Figure 6. Downburst of wind (Source: International Civil Aviation Organization; illustration with offset tracks)

A downburst (Figure 6) is a “concentrated, severe downdraft which accompanies a descending column of precipitation underneath [a thunderstorm] cell.”¹⁸ A microburst is a type of downburst. Less than 4 km in diameter, it is of shorter duration, but often of greater intensity than a downburst. “A rapid drop in temperature and a sharp rise in pressure characterize this horizontal flow of gusty surface winds.”¹⁹

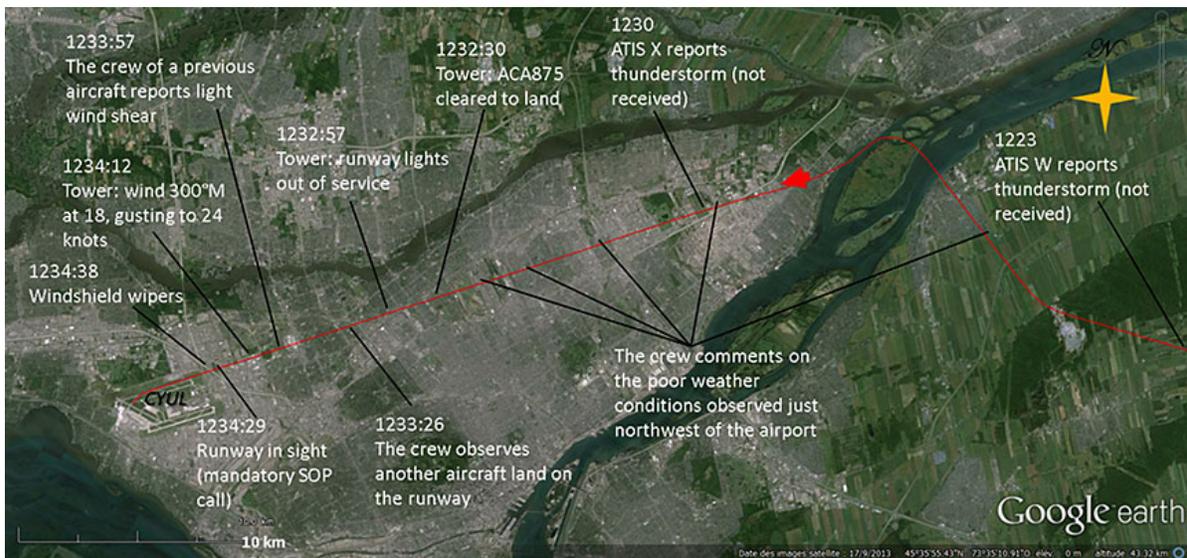
Figure 10. Aircraft flight path on approach to Montréal/Pierre Elliot Trudeau International Airport in relation to the available weather information (Source: Google Earth, with TSB annotations)

At 1223 and 1230 respectively, the ATIS Whiskey and ATIS X-ray messages reported a thunderstorm (these messages were not received (Figure 10)).
