AVIATION INVESTIGATION REPORT
A15W0069

LOSS OF CONTROL AND COLLISION WITH TERRAIN
CONAIR GROUP INC. (DBA CONAIR)
AIR TRACTOR AT-802A FIRE BOSS AMPHIBIAN, C-FDHV
COLD LAKE, ALBERTA, 25 NM NW
22 MAY 2015

Loss of control and collision with terrain

Air Tractor AT-802A Fire Boss Amphibian, C-FDHV

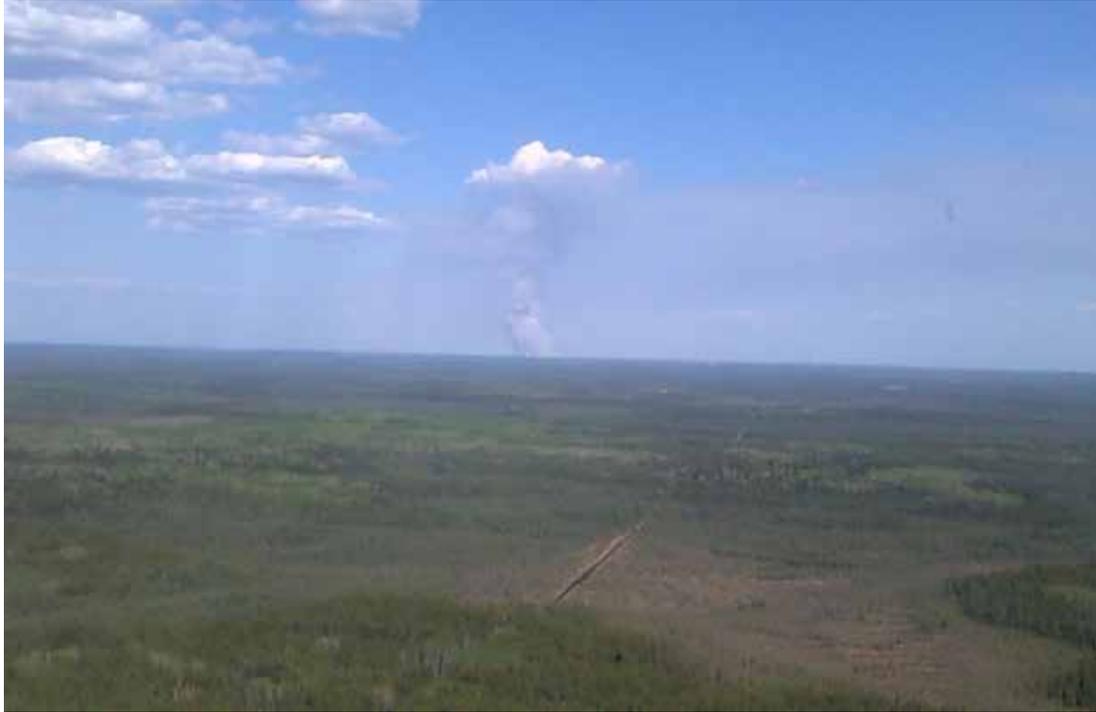
Photo 2. The well-defined smoke column of fire LWF-122-15 at 1622 (Source: Government of Alberta)

When the atmosphere is unstable, parcels of air can continue moving more easily than in stable conditions. This increases the intensity of the rotation of a column of rising air by stretching it and reducing its diameter. To conserve angular momentum, the rotation increases. An unstable atmosphere is characterized by a high adiabatic lapse rate, fair weather cumulus clouds, and good visibility. Countryman¹⁴ described how these conditions affect the smoke column from the fire. The smoke column rises rapidly to a considerable height, initially well defined (Photo 2) and subsequently spreading out. The smoke column may also show signs of rotation, if present (Photo 3).
