MARINE INVESTIGATION REPORT

M04F0017

GROUNDING

TANK BARGE *KTC 115*

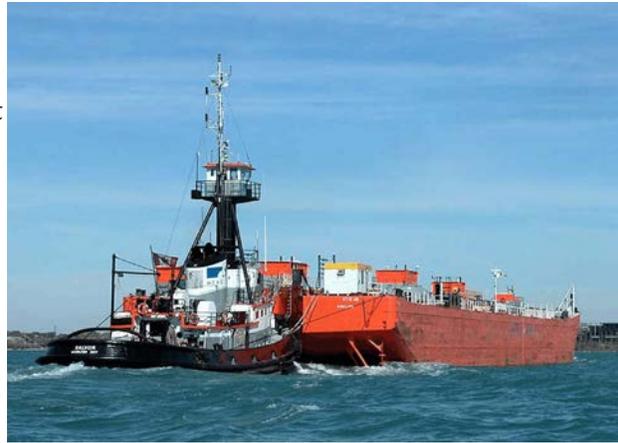
The *KTC 115* is a single-hull tank barge with 10 tanks (five port and five starboard) with a total capacity of 11 176 tonnes. The barge is equipped with a notch aft into which the tug is fitted when in the pushing mode. A single danforth anchor is located forward. If the barge becomes separated from the tug, the anchor cannot be dropped remotely.

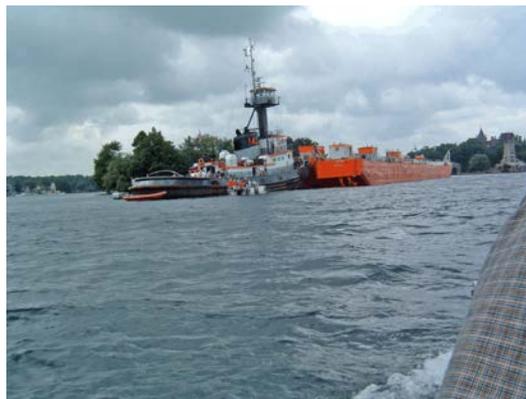
In the engine room, the chief engineer took steering control and switched the engine room control first to emergency and then to the NFU steering. However, the rudder did not respond to commands. Steering with engines, the tug proceeded to the south side of the channel near the entrance to Alexandria Bay. When the chief engineer inspected the steering gear, he found that the telemotor feedback rod had broken. Following the installation of a temporary replacement rod, steering was regained and the vessel proceeded across the channel to locate the barge. After sending out crew members in a small boat to take soundings around the grounded barge, the *Salvor* proceeded to reconnect to the barge.

A damage survey of the barge by divers revealed inset bottom plating and three cracks in the bottom of the forward-most starboard tank. A rope was found entangled in the port propeller of the tug, and the tips of the starboard propeller blades were found to be damaged.

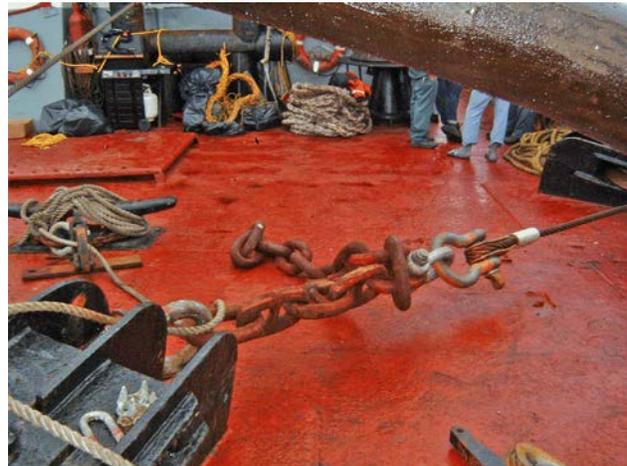
The towing arrangement comprised a notch in the transom of the barge that housed the bow of the tug (see Photo 1). The securing arrangement comprised a 2½-inch braided polypropylene hawser from the bow of the tug to a bitt on the barge and similar hawsers, one at each corner of the barge's notch to the port and starboard shoulder of the tug (see Figure 2). To facilitate steering and backing, single 1½-inch-diameter, 6 x 36 face wires were rigged between quarter bits on the barge and the after deck of the tug. The starboard wire was shackled to a 2-inch steel stud chain, which, in turn, was shackled to a fairlead mount on the deck of the tug. The port face wire was connected through a fairlead to the tug's towing winch that was used to tension the tug in the notch.

Post-occurrence examination of the rigging found that two links of the chain connecting the starboard face wire had failed, and that the port face wire had also parted at the point where it would normally lead through the port bulwark fairlead. Tests on the failed chain links indicate that they failed from sudden overstress.⁷ The tests found that there were no significant corrosion or defects in the failed chain links and that the breaking strength was consistent with standards for that size chain. No certification, inspection, or maintenance records were available on board for either the chain or wire, although a certificate from the wire rope manufacturer was produced by the owner some three months after the occurrence. The history of the failed chain could not be determined by the company; however, it was in poor overall condition with studs loose or missing from some links. Indications are that it probably came from a marine salvage yard.
