RAILWAY INVESTIGATION REPORT
R07T0110

MAIN-TRACK DERAILMENT

CANADIAN NATIONAL
TRAIN M36321-26
MILE 264.94, KINGSTON SUBDIVISION
COBOURG, ONTARIO
28 APRIL 2007

Report Number R07T0110

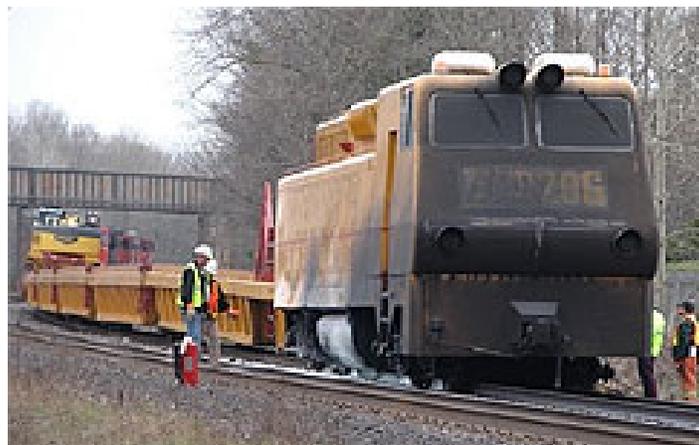
Photo 5. Herzog articulated maintenance-of-way machine

The Herzog machine is a customized 495-foot maintenance-of-way machine designed for self-propelled operation at up to 50 mph (see Photo 5). In work mode, the machine is operated using a portable remote control device that can be mounted in the control cab at either end, or carried by the operator.

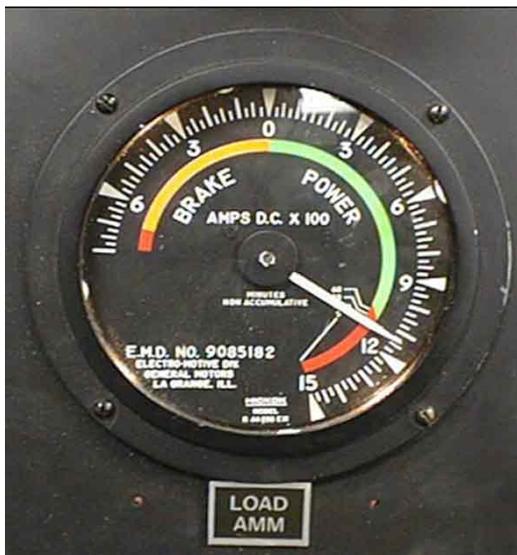
Photo 6a. Analog loadmeter display

Locomotives acquired by CN before 2005 display dynamic braking in amperage (see Photo 6a). Locomotives purchased after 2005 display dynamic braking effort as tractive effort (see Photo 6b). At the time of this occurrence, the lead locomotive did not carry an English version of the operating manual to explain the operator interface or the LER recorder functions, although copies of the manual were available at the crew office in Belleville.
