**RAILWAY INVESTIGATION REPORT
R08T0029**

MAIN-TRACK DERAILMENT

**CANADIAN NATIONAL RAILWAY
FREIGHT TRAIN M39671-14
MILE 33.24, OAKVILLE SUBDIVISION
ALDRSHOT, ONTARIO
18 FEBRUARY 2008**

Report Number R08T0029

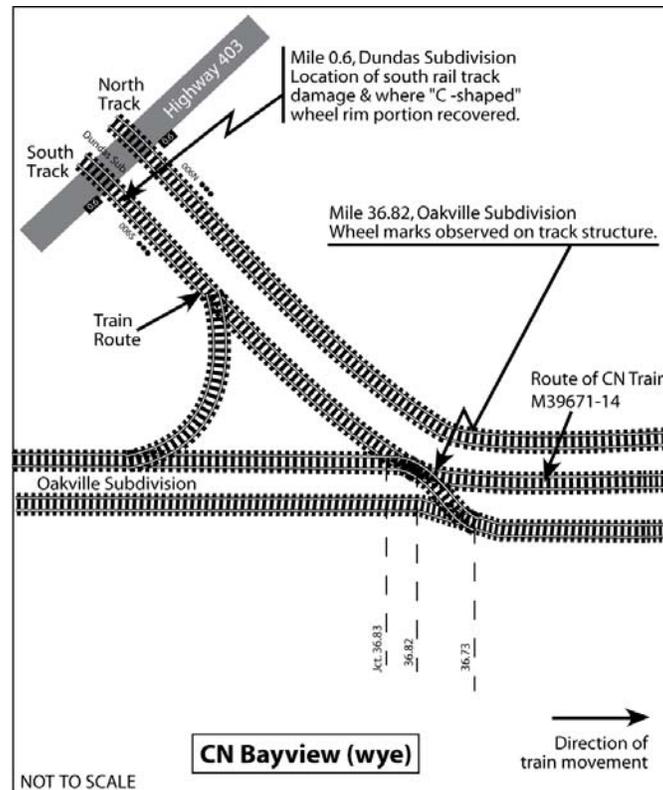
Figure 2. Bayview Wye Schematic

Rail damage extended eastward, through the east leg of the wye (a left-hand curve) onto the number 2 track of the Oakville Subdivision where the first signs of tie damage were observed at Mile 36.82 (see Figure 2). Three additional large pieces of a broken wheel were located at a damaged crossover switch at Snake (Mile 36.22). Track damage continued from this point to the King Road crossing at Mile 33.31.
