**RAILWAY INVESTIGATION REPORT  
R14T0160**

**MAIN TRACK DERAILMENT**

**CANADIAN NATIONAL RAILWAY  
FREIGHT TRAIN M-310-31-09  
MILE 127.52, KINGSTON SUBDIVISION  
BROCKVILLE, ONTARIO  
10 JULY 2014**

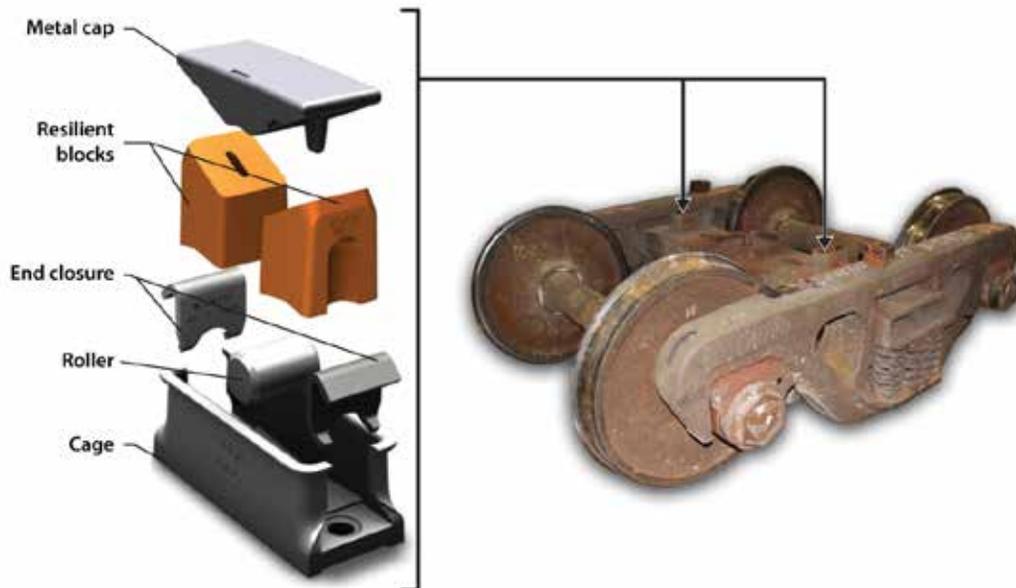
Figure 5. Constant contact side bearing similar to the one installed on car BCOL 730558  
(Source: A. Stucki Company, *Product Guide*, with TSB modifications and annotations)

The car was equipped with standard Barber S2 trucks that had Stucki standard travel CCSBs installed. While there are several different CCSB designs, this type of CCSB comprises 2 resilient members (i.e. blocks), a roller, a metal cap, and a cage (Figure 5).

Car repair records indicate that on 18 June 2007, the car was taken to CN's shop in Memphis, Tennessee, where broken A-end friction castings were repaired. There is no indication that CCSB components were inspected or replaced at that time. On 03 July 2014, the car was on a shop track at CN's MacMillan Yard in Toronto, where several repairs were performed on the

car, including the application of a carrier iron shim to its B-end to adjust the height. There is no indication that the side bearing clearance and the side bearing height were verified at that time.
