**MARINE INVESTIGATION REPORT**  
**M06F0024**

**CREW MEMBER LOST OVERBOARD**

**SAIL TRAINING VESSEL *PICTON CASTLE***  
**376 nm SSE OF LUNENBURG, NOVA SCOTIA**  
**08 DECEMBER 2006**

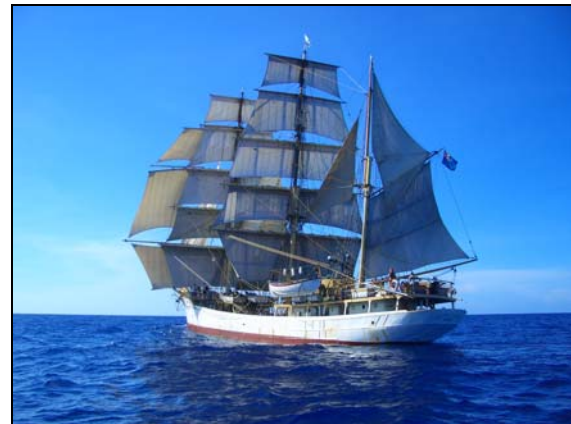
Photo 1. *Picton Castle* (courtesy D. Moreland)

Built in England in 1928 as a riveted steel-hulled side trawler, the *Picton Castle* was rebuilt in 1955 as a freighter. From 1996 to 1997, the vessel was refitted in Lunenburg, Nova Scotia (its operating base), as an ocean-going three-masted barque-rigged sail training vessel (see Photo 1). The decks are oiled pine wood. The hull is subdivided by five transverse watertight bulkheads, with watertight doors providing access to the main compartments.
